Walk/Bike Assessment

Main Street

Northampton, MA

January 18, 2016

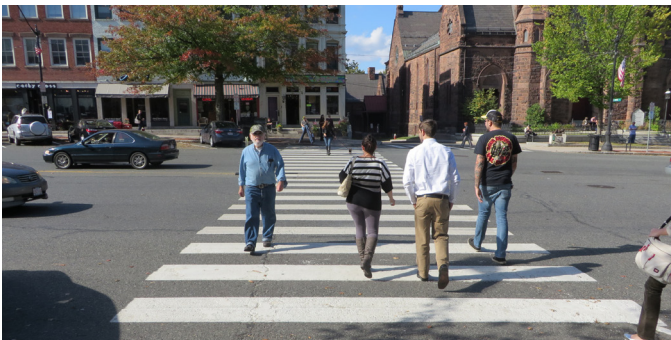
Pedestrian activity in the crosswalk across Main Street at Center Street

1. Narrow Main Street to shorten crossing distances by installing curb bump-outs and pedestrian refuge islands. The streetscape design needs to accommodate people using transit, riding bicycles, walking, and driving cars.
2. Improve sight distance for pedestrians by removing parking with 20 feet of crosswalks.
3. Evaluate signal timing for consistent pedestrian phasing and upgrade pedestrian signal equipment to include countdown indications and accessible pedestrian signals (APS).
4. Enforce ordinances that keep sidewalk walking zones clear. Educate business owners and event promoters about appropriate location of signage and tables.
5. Upgrade all curb ramps and install detectable warning strips to comply with accessibility requirements on all sidewalks along the corridor.

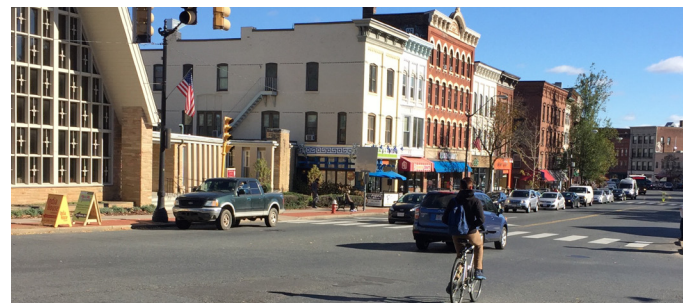
Bicyclist negotiating Main Street in Northampton, MA

1. Install bike facilities on Main Street through the study area. In the short-term, this may be accomplished as a retrofit project using signs and striping. In the long-term, this should be included as part of a full reconstruction of Main Street to provide physically separated bike lanes.
 - Alternative 1: Separated bike lane between angled parking and the curb.
 - Alternative 2: Bike lane between parking and the travel lanes, including a conversion to back-in angle parking.
2. Implement a truck restriction on Main Street through downtown.
3. Install wayfinding signage to New Haven Northampton Canal Line multi-use trail and other points of interest.
4. Install bike parking in convenient, secure, and visible locations throughout the Main Street corridor.

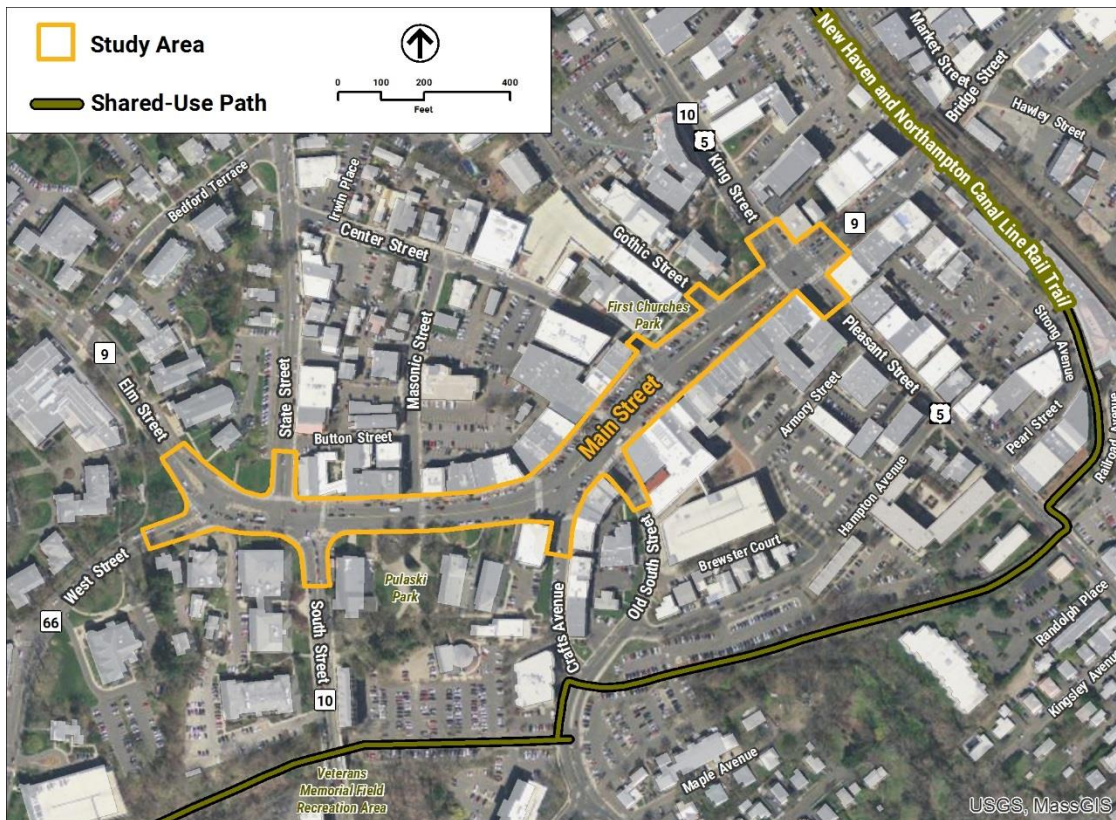
Figure 1 - Assessment Area Map

The study area for the Main Street assessment shown in **Figure 1** includes Main Street from West Street (Route 66) to King Street/Pleasant Street (US Route 5), including the following intersections:

- Main Street/Elm Street (Route 9) at West Street (Route 66);
- Main Street at State Street/New South Street (Route 10);
- Main Street at Masonic Street;
- Main Street at Crafts Ave/Crackerbarrell Alley;
- Main Street at Old South Street;
- Main Street at Center Street;
- Main Street at Gothic Street; and
- Main Street at King Street (Route 10, US Route 5)/Pleasant Street (US Route 5).

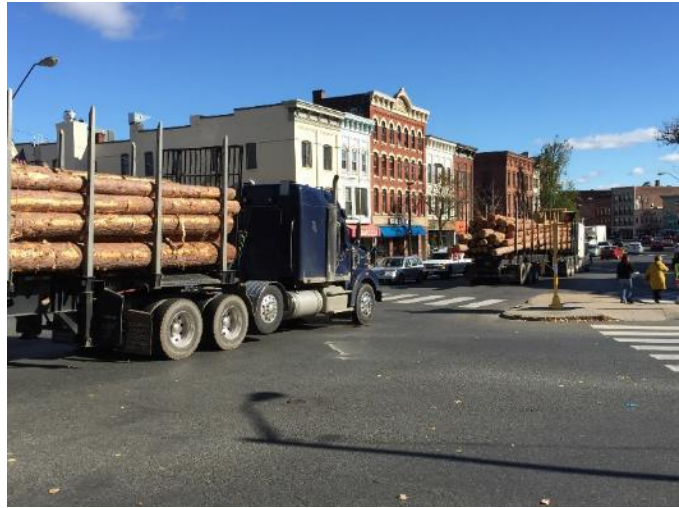
Members of the team observed several large tractor trailer trucks and logging trucks traveling through downtown which did not appear to be local trips. City staff noted that large vehicles typically have to detour up King Street to Damon Road in order to avoid the low railroad bridge east of King Street and continue east on Route 9 towards Interstate 91. Given that the existing through route is extremely indirect and that the heavy truck volumes are incompatible with the heavy volumes of people walking and on bikes, the City and MassDOT should explore strategies to reroute through trucks away from Main Street through downtown. It would be necessary to provide a sufficient alternate route for through trucks on Route 9.

Figure 2 - Logging trucks pass through the New South Street intersection on Main Street.

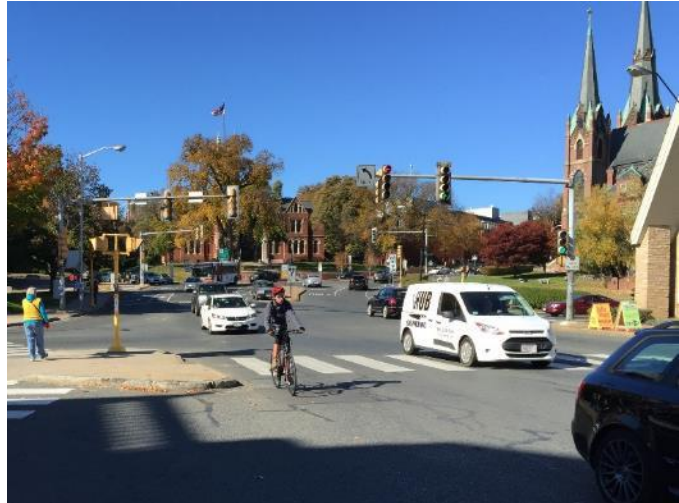
Figure 3 - A bicyclist passes through the New South Street intersection on Main Street.

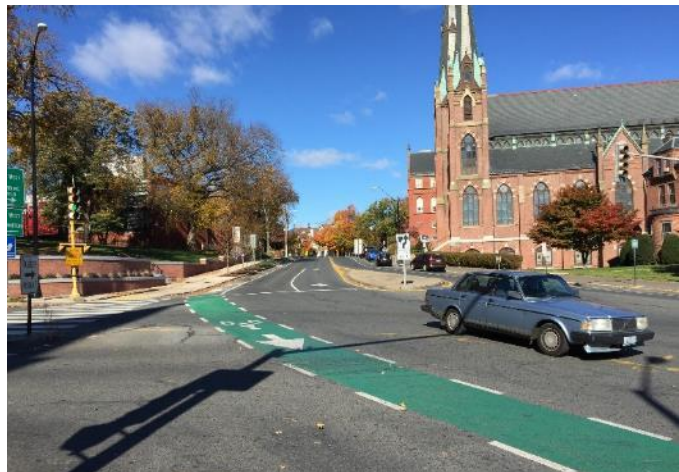
Bike lanes are provided on Elm Street west of State Street/New South Street. The eastbound bike lane includes green paint through the intersection of West Street to highlight the conflict zone. Members of the team noted that eastbound vehicles on Main Street that plan on turning right at New South Street frequently transition through the bike lane over a long distance due to the road alignment and curvature, creating a large conflict zone. The eastbound approach to State Street/New South Street also provides a bike box across all four lanes, however, the markings are faded.

Figure 4 - Bike lane intersection markings transition through the West Street intersection.

Members of the team noted that the wide, multi-lane approaches make it difficult for bicyclists to make the left turn to State Street or New South Street, especially for bicyclists who arrive on green and are unable to use the eastbound bike box. The City should consider installing two-stage turn queue boxes at the State Street and New South Street to allow bicyclists to make the left turn during the side street green phase. The city should also restripe the existing bike box and install green pavement markings.

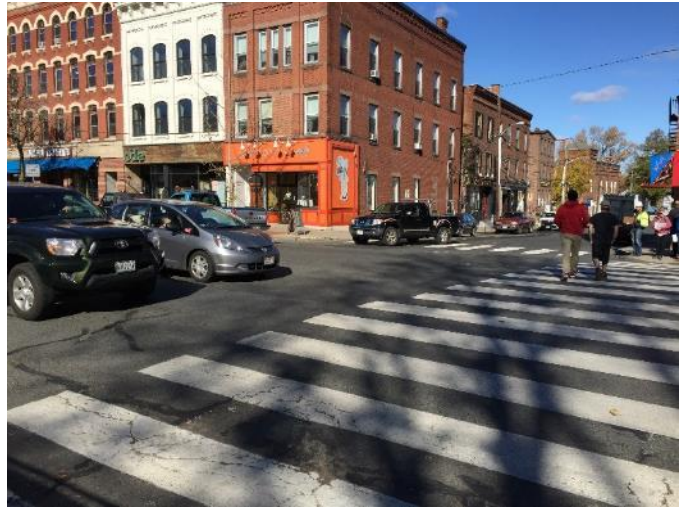
Members of the team noted that parking adjacent to the crosswalk on the eastbound and westbound approaches limits sight distance for pedestrians. The City should consider removing one parking space on each approach to provide sufficient sight distance for pedestrians crossing Main Street. Members of the team also observed that the existing bus stop on Main Street eastbound west of Masonic Street is heavily utilized, and that the narrow sidewalk has limited space for pedestrians to disembark from the bus, especially when the wheelchair loading ramp was deployed from the bus. Construction work is ongoing for the adjacent park, and it is expected that the park will include a bus shelter, wider sidewalk facilities, and bike parking.

Figure 6 - Pedestrians cross Main Street at Masonic Street.

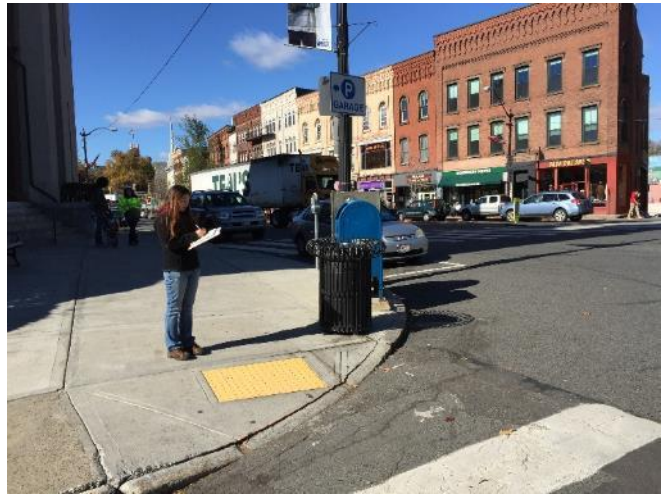
Members of the team noted that the existing parking, sidewalk furniture, and roadway geometry at the Crafts Avenue intersection results in poor sight distance and high vehicle turning speeds which impact both crosswalks. The City should consider removing the two parking spaces and relocating sidewalk furniture in front of City Hall in order to improve sight distance to both crosswalks. In the long term, the City should consider reconstructing the south side of Main Street to provide curb geometry that follows the curvature of the roadway and provides a reduced turning radius to Crafts Ave. This will reduce turning speeds and improve driver and pedestrian expectancy.

Figure 7 - Parked cars block sight distance for pedestrians at Crafts Avenue.

- Remove the two parking spaces and relocate sidewalk furniture in front of City Hall in order to improve sight distance to the crosswalk across Main Street and to the crosswalk across Crafts Ave.
- Remove the angle parking space east of Crackerbarrell Alley to improve sight distance to the crosswalk across Main Street.
- Remove the angle parking spaces on both sides of Main Street within 20 feet of the crosswalk east of Old South Street to improve sight distance to the crosswalk and prevent drivers from backing into the crosswalk.
- Provide temporary curb extensions using paint and flex posts.

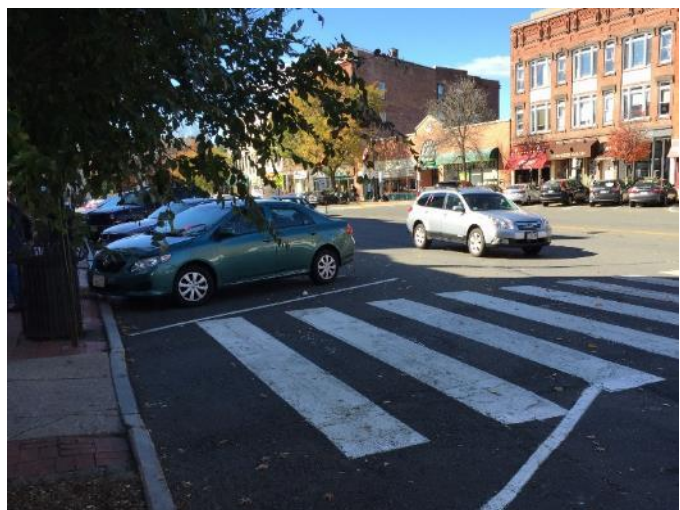
Members of the team also noted that the angle parking spaces adjacent to both crosswalks across Main Street limit sight distance for pedestrians. At the crosswalk across Main Street, the handicap accessible parking space on the north side west of the crosswalk requires drivers to back into the crosswalk in order to exit the space. The City should remove four angle parking spaces and relocate the handicap accessible space in order to improve sight distance and prevent drivers from backing into the crosswalk. As a long term measure, the City should consider constructing curb extensions at both crosswalks, which may create an opportunity for a pocket park. In the short term, it may be necessary to

Figure 8 - Parked cars block sight distance to a midblock crosswalk.

provide temporary curb extensions using flex posts to prevent short-term parking from occurring in the clear zones adjacent to the crosswalks. Curb extensions may include bike parking within the area formerly occupied by the angle parking spaces adjacent to the crosswalk, however care should be taken to ensure that proper sight lines are maintained for pedestrians.

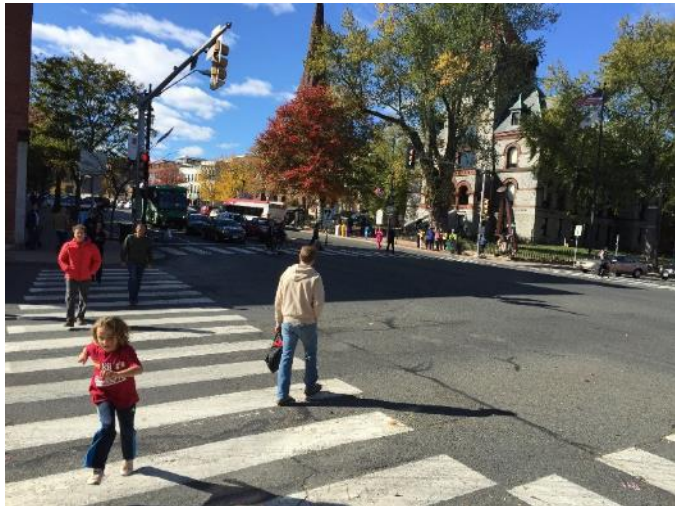
Members of the team noted that due to the large size of the intersection and the complex signal phasing, pedestrians typically comply with the traffic signals and cross during the exclusive pedestrian phase. Many pedestrians were observed crossing the intersection diagonally during the pedestrian phase. The City should consider installing continuous corner ramps to allow for diagonal crossing and updating the signal timing to provide appropriate clearance for the diagonal crossing. Members of the team suggested that the intersection may be reconstructed as a raised table intersection, allowing for pedestrian crossing in all directions during the pedestrian phase.

Figure 9 - Pedestrians cross during the exclusive pedestrian phase.

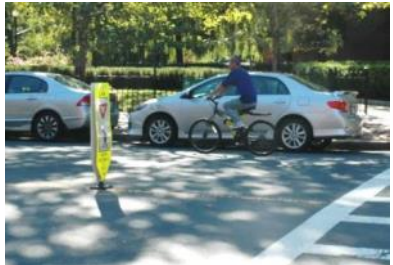
| Facility Type | Description | Sample Photo |
|---|---|--|
| In-Street Pedestrian Crossing Sign | A removable high-visibility sign placed on the centerline of a street prior to a crosswalk to alert motorists to yield when pedestrians are present in the crosswalk. | |

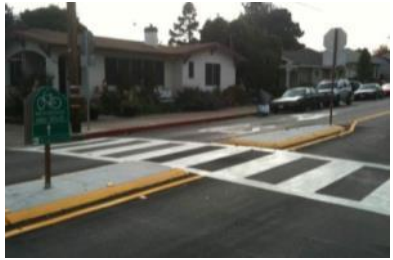
| Facility Type | Description | Sample Photo |
|---|--|--|
| Pedestrian Refuge Island | Raised median or island that provides in-street refuge at a pedestrian crossing. The crosswalk may be angled at refuge to encourage pedestrians to make eye contact with oncoming traffic. | |

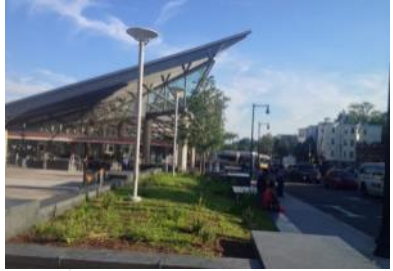
| Facility Type | Description | Sample Photo |
|---|--|--|
| Pedestrian-Scale Lighting | Light fixtures used to illuminate a sidewalk or pathway typically closer to the ground and placed closer together than roadway lighting. | |

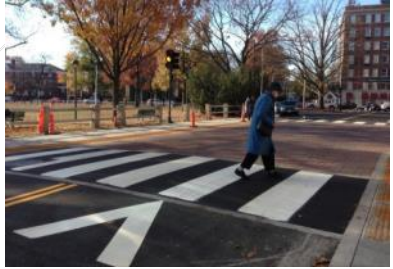
| Facility Type | Description | Sample Photo |
|---|--|--|
| Raised Intersection | A crosswalk or entire intersection raised from street-level to sidewalk-level. This elevated crossing increases pedestrian priority and visibility and slows approaching vehicles. | |

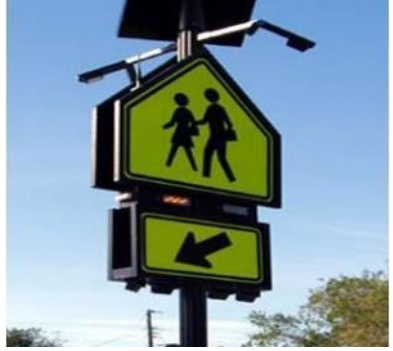
| Facility Type | Description | Sample Photo |
|---|--|--|
| Rectangular Rapid Flash Beacon | An on-demand activated flashing beacon with a “wig-wag” pattern that alerts motorists to pedestrians in the crosswalk. Typically used on lower volume and lower speed streets. | |

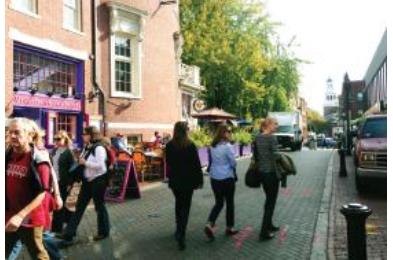
| Facility Type | Description | Sample Photo |
|---|--|--|
| Shared Street | The road surface is typically at the same level as the sidewalk surface to create a continuous pedestrian space. A shared street is for motorists, pedestrians, and bicyclists. | |

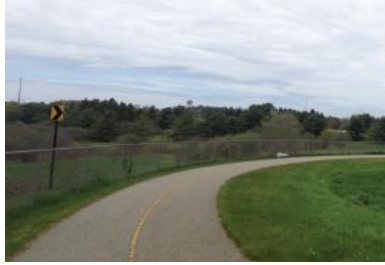
| Facility Type | Description | Sample Photo |
|---|--|--|
| Shared-use Path | A two-way path that is open for bicyclists, pedestrians, and other non-motorized users. The path is typically ADA-compliant and ranges between 10 to 14 feet wide. | |

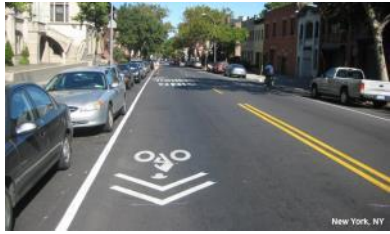
| Facility Type | Description | Sample Photo |
|---|--|--|
| Shared Lane Markings | Designate positioning for cyclists within shared travel lanes and alert drivers to the presence of cyclists. Shared lane markings should be considered temporary measures until future improvements can provide full bicycle facilities. | |

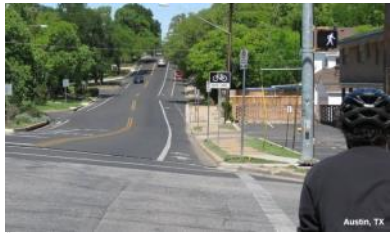
| Facility Type | Description | Sample Photo |
|---|--|--|
| Bike Lane | Exclusive travel lane for bicycles, typically located along the right side of the travel lanes on a two-way street, however may be located on either side of a one-way street. | |

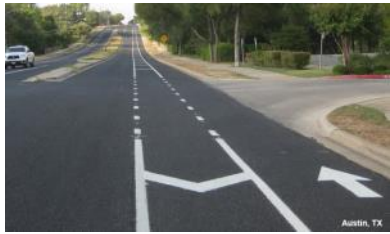
| Facility Type | Description | Sample Photo |
|---|--|--|
| Buffered Bike Lane | Bicycle lane with a painted buffer separating cyclists from adjacent vehicle traffic and/or adjacent parking lanes. | |

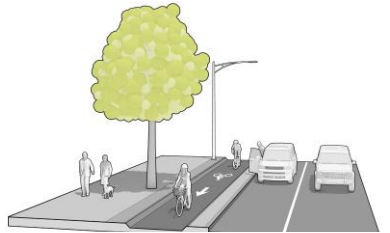
| Facility Type | Description | Sample Photo |
|---|--|--|
| Separated Bike Lane | Bicycle lane protected from vehicle traffic by adjacent vertical elements, including flex posts, planters, parked cars, curbs, or raised medians. | |

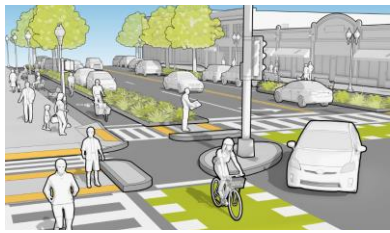
| Facility Type | Description | Sample Photo |
|---|--|--|
| Protected Intersection | Physical separation carried through the intersection to minimize exposure to conflicts, reduce speed at conflict points, communicate right-of-way priority, and provide adequate sight distance between all users. | |

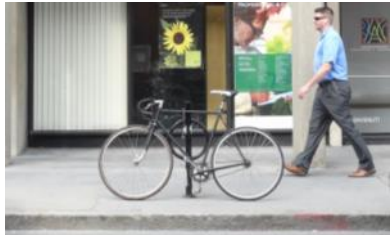
| Facility Type | Description | Sample Photo |
|---|--|--|
| Individual Bike Parking | Individual bicycle racks typically placed along sidewalks to provide incremental bicycle parking throughout a larger area. Racks should be designed to support the bicycle at two points. | |
